LANDSLIDES AND RELATED FEATURES

OF THE RIPLEY, W. VA. QUADRANGLE

GREGORY C. OHLMACHER

OPEN FILE MAP 83-80 (G-3)

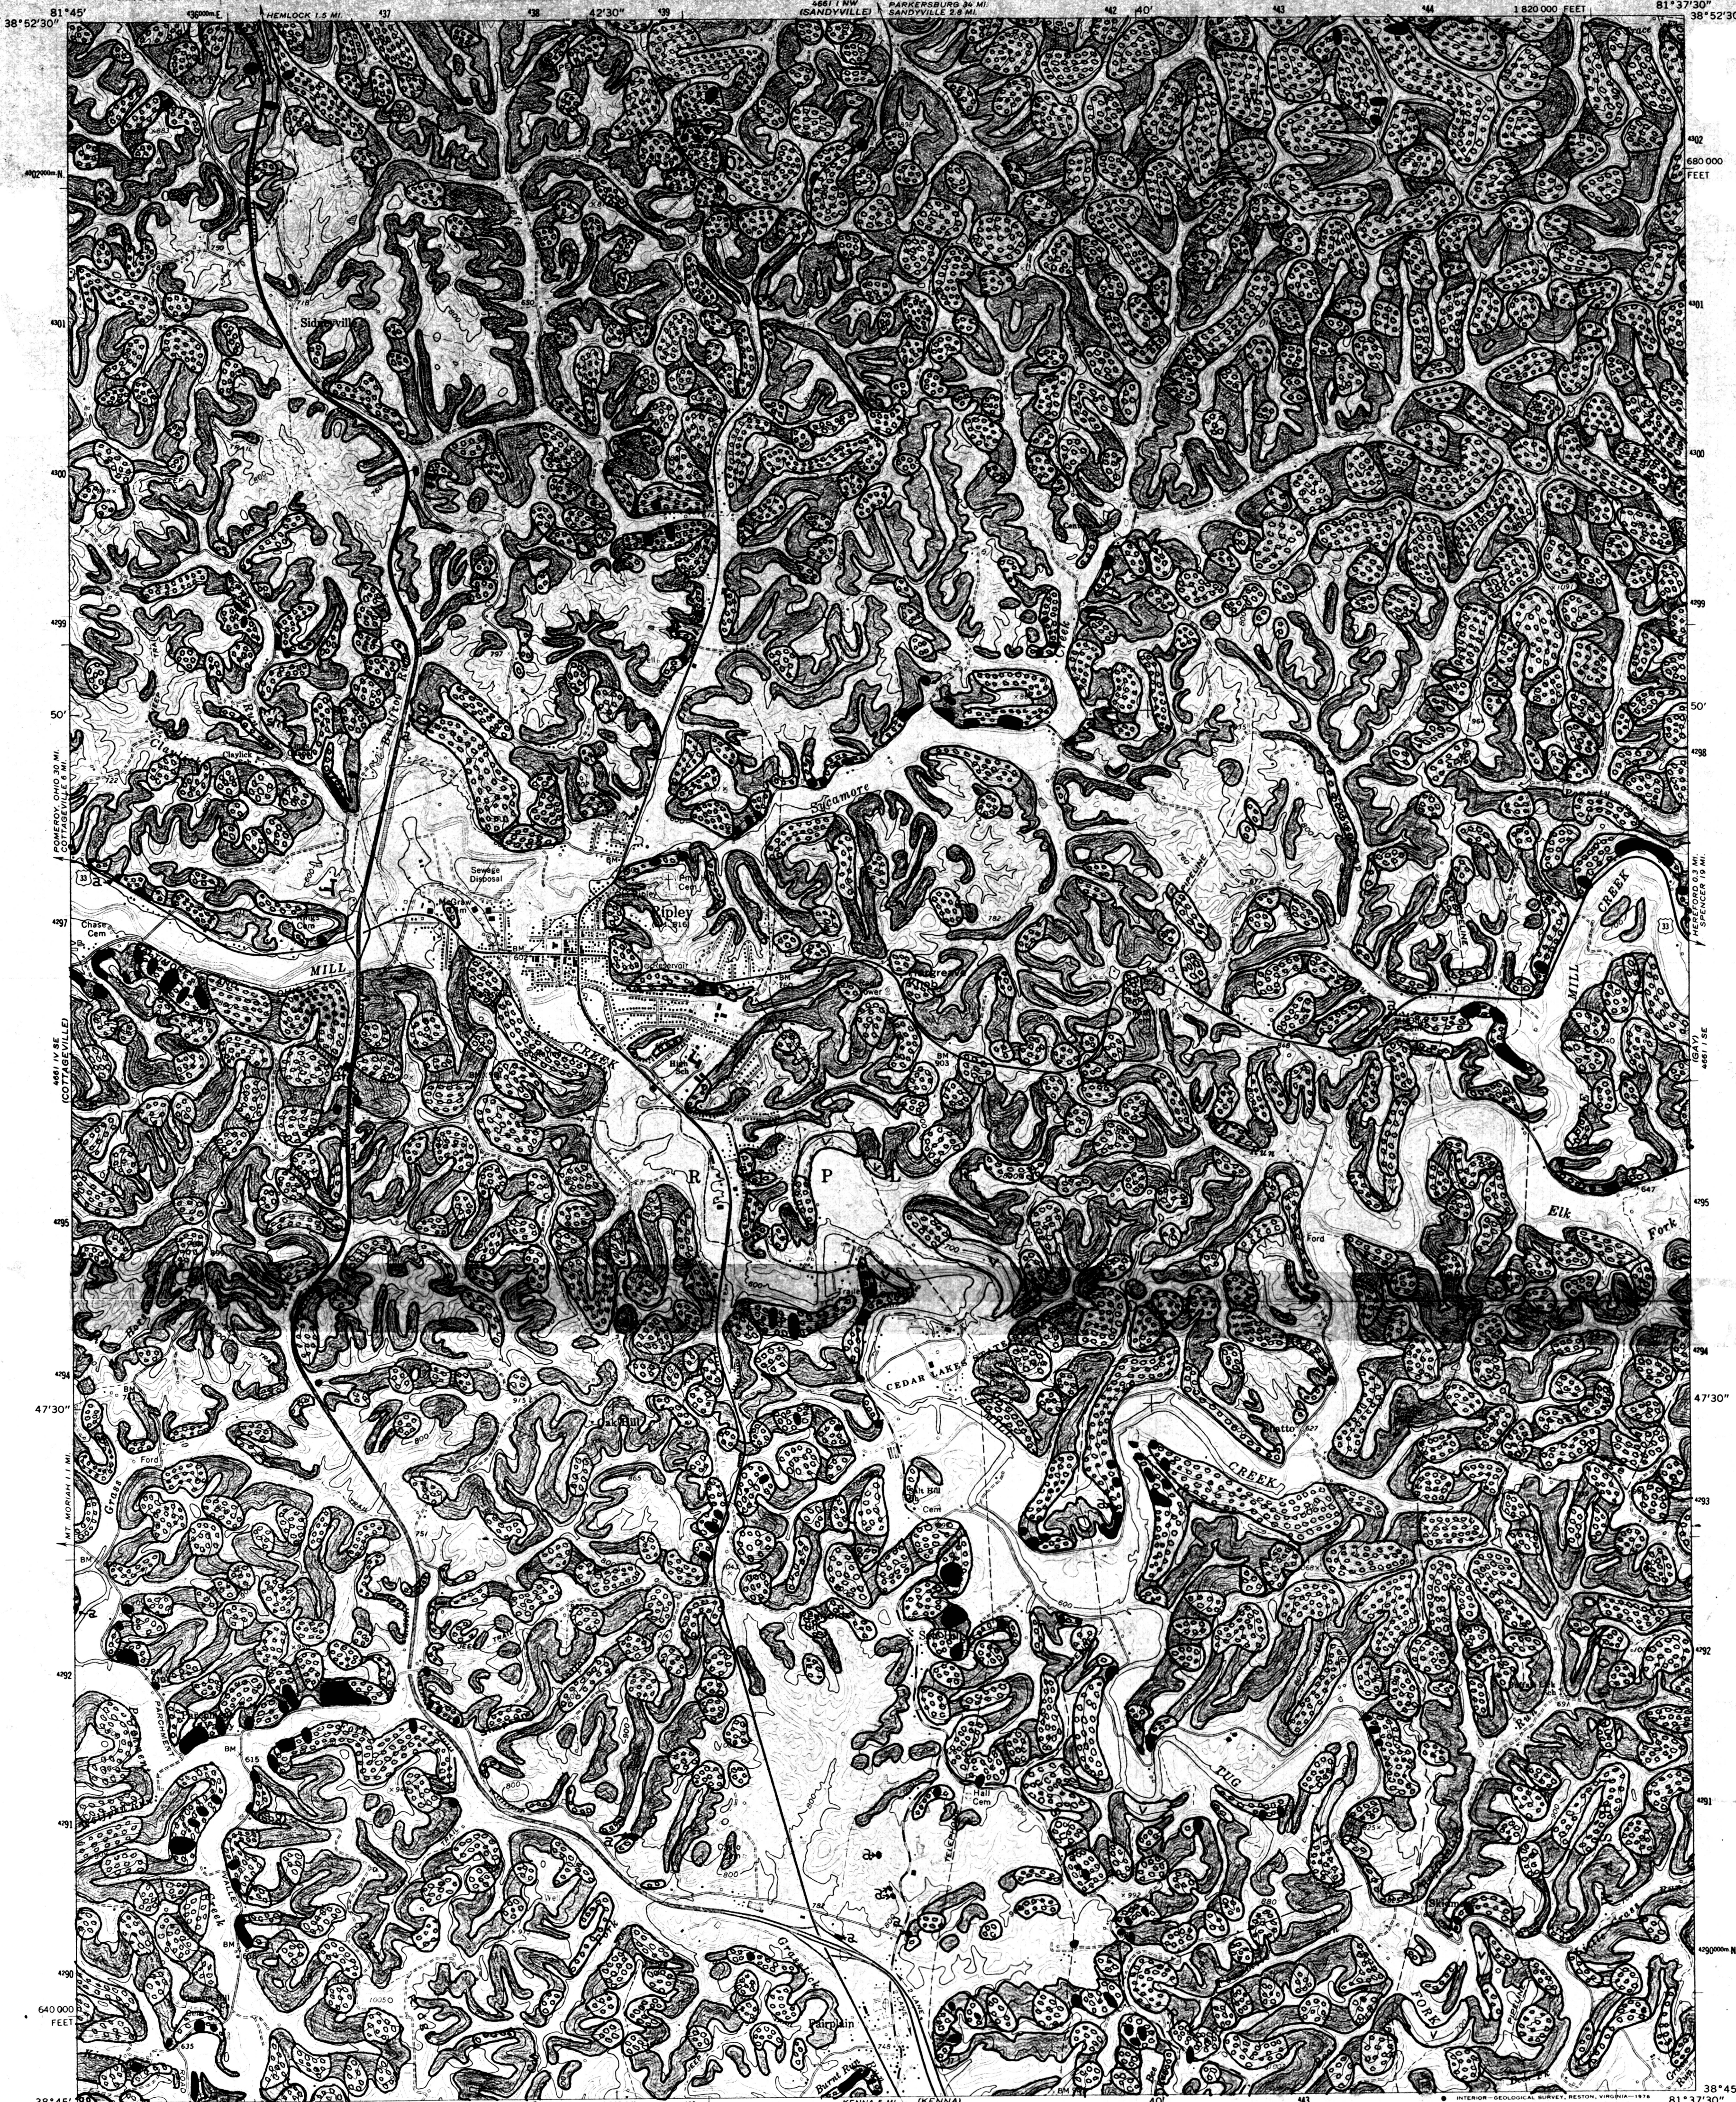
RIPLEY, W. VA.
SW 1/4 RIPLEY 15 QUADRANGLE
N3845-W8137.5/7.5

Landslides and related features interpreted
from aerial photographs:
1:60,000 SCALE BLACK AND WHITE 1960
1:125,000 SCALE COLOR INFRARED 1973
1:80,000 SCALE BLACK AND WHITE 1975

Photointerpretation and field check 1979.
This map has not been edited or reviewed
for conformity with Geological Survey
standards and nomenclature.

ACTIVE OR RECENTLY ACTIVE LANDSLIDE

Complex landslide composed of earthflow, debris
slide, earth and rock slump. Identified from
historical records, and from scars, debris and
other field evidence. Ground extremely unstable,
sliding accelerated by excavation, loading and
changes in drainage conditions. May include
areas with several active slides too small to
be shown separately.

OLD LANDSLIDE

Area of extensive hummocky ground caused by
earthflow and earth and rock slump. Lacks
clear evidence of active sliding. Relatively
stable in natural, undisturbed state,
generally not affected by small structures properly
sited in areas away from the edge of the toe,
can be reactivated by extensive, rapid exca-
vation, loading, and changes in ground water and
surface water conditions. Area of old landslide
probably includes recent ones not identified
from field evidence or otherwise documented.
Upslope boundary of landslide generally defined
by modified scarp, but downslope (toe) may be
gradational and not well defined.

COLLUVIAL SLOPE

Valley wall along major streams with slope as
steep as 40° (85%), stony, clayey silt soil up
to 50 ft. (15 m) thick, commonly buttressed by
a terrace or bench at the toe of the slope, very
susceptible to sliding by cutting of toe area,
removal of terrace or bench, and overloading;
slide commonly activated without apparent cause.
